# DANLERS

CAPLOAD - INS194.indd/2

Product: 2-wire, plated, time lag switch.

CAPLOAD - INS194.indd/1

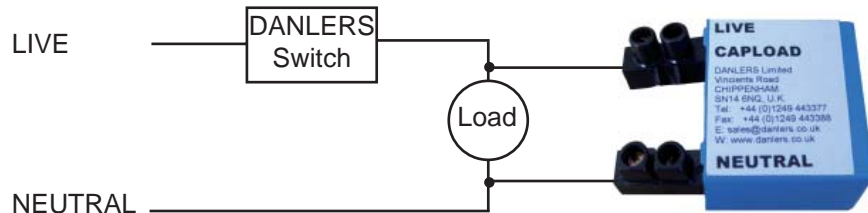
Problem: Intermittent function.

Cause: Resistive load less than 40W (approx 100W inductive).

Solution: Wire a CAPLOAD power factor correction capacitor in parallel with load.

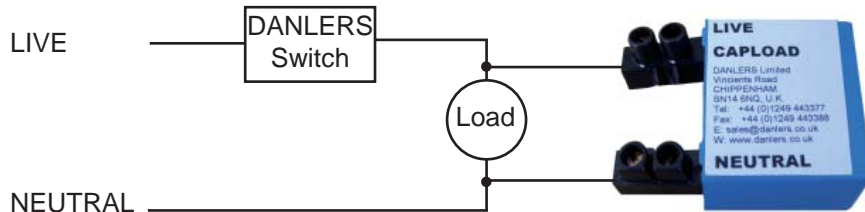
Product: 2-wire PIR switch.

Problem: Device locked on or off.

Cause: Resistive load less than 40W (approx 100W inductive).

Solution: Wire a CAPLOAD power factor correction capacitor in parallel with load.  
Rechargeable battery may need to be removed, recharged and replaced.
