Test Report:

Fire resistance test in
accordance with BS EN
1364-1:1999 on a non-
loadbearing wall
incorporating Scolmore
Doubled Switched
electrical sockets

Prepared for:
Scolmore International Limited,
1, Scolmore Park,
Landsberg
Lichfield Road Industrial Estate,
Tamworth,
Staffordshire,
B79 7XB

Test report number 239762

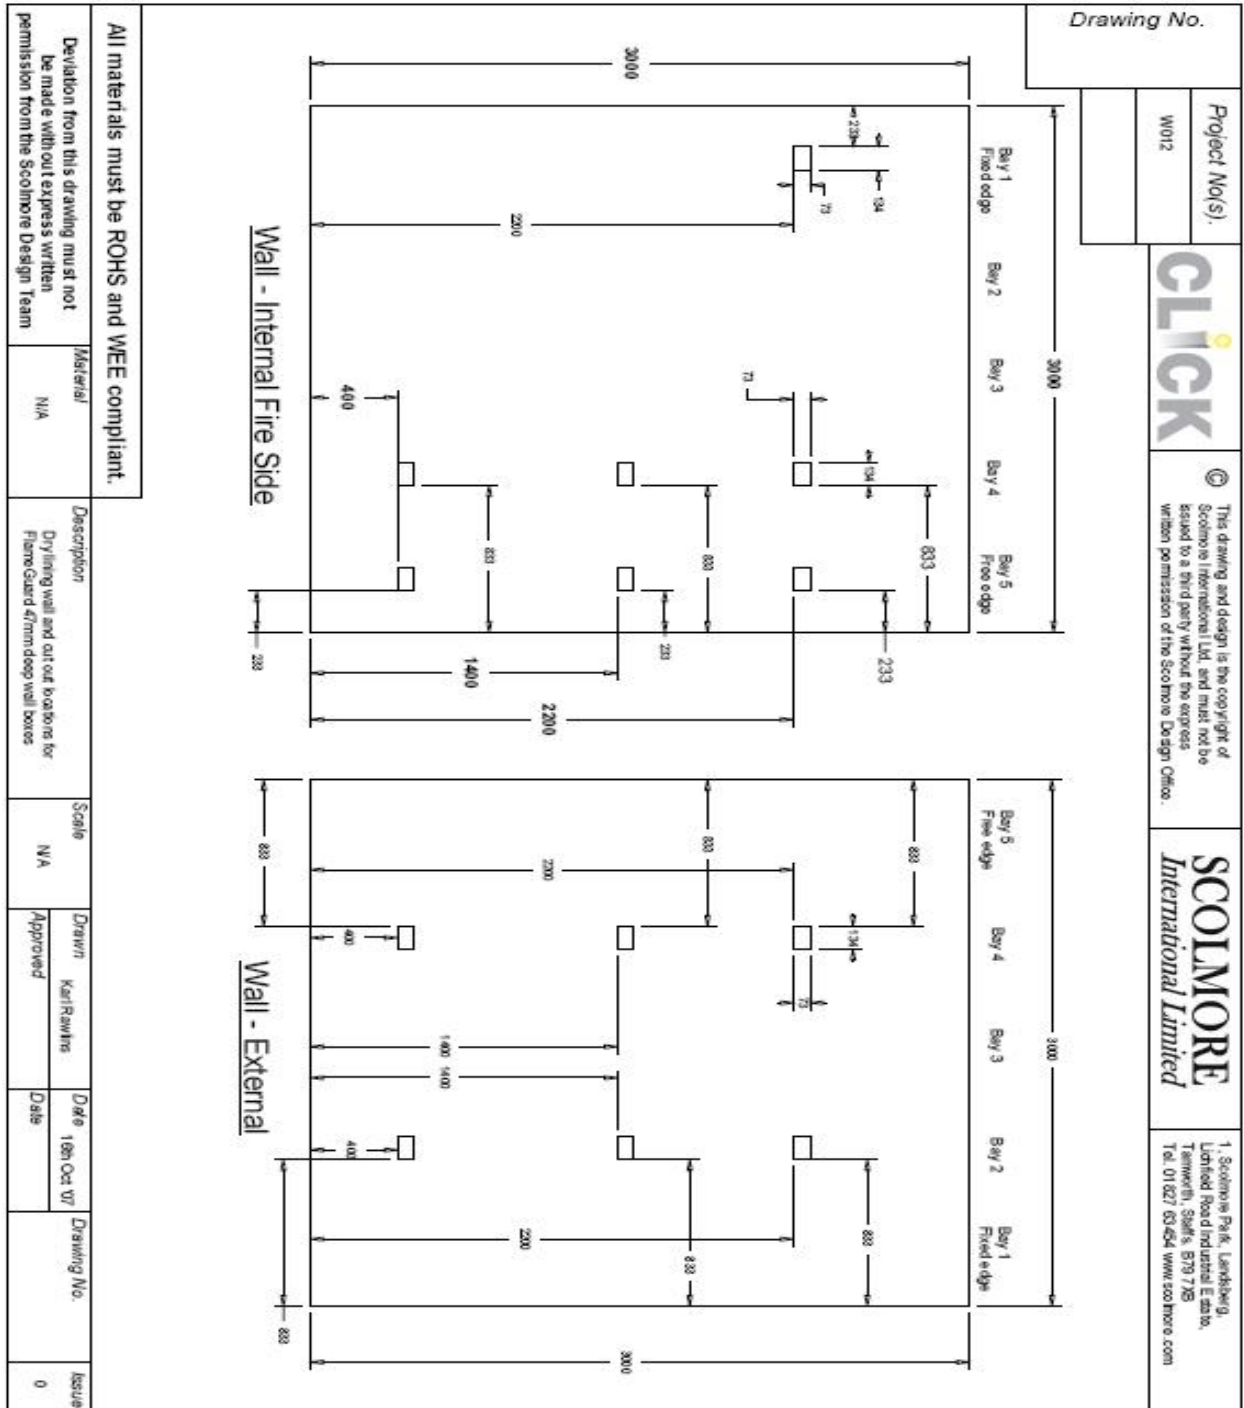
Figure 3: Wall Layout with cut-out positions

The construction is shown in Figures 2 to 6 and also before the test in Photos 1 and 2.

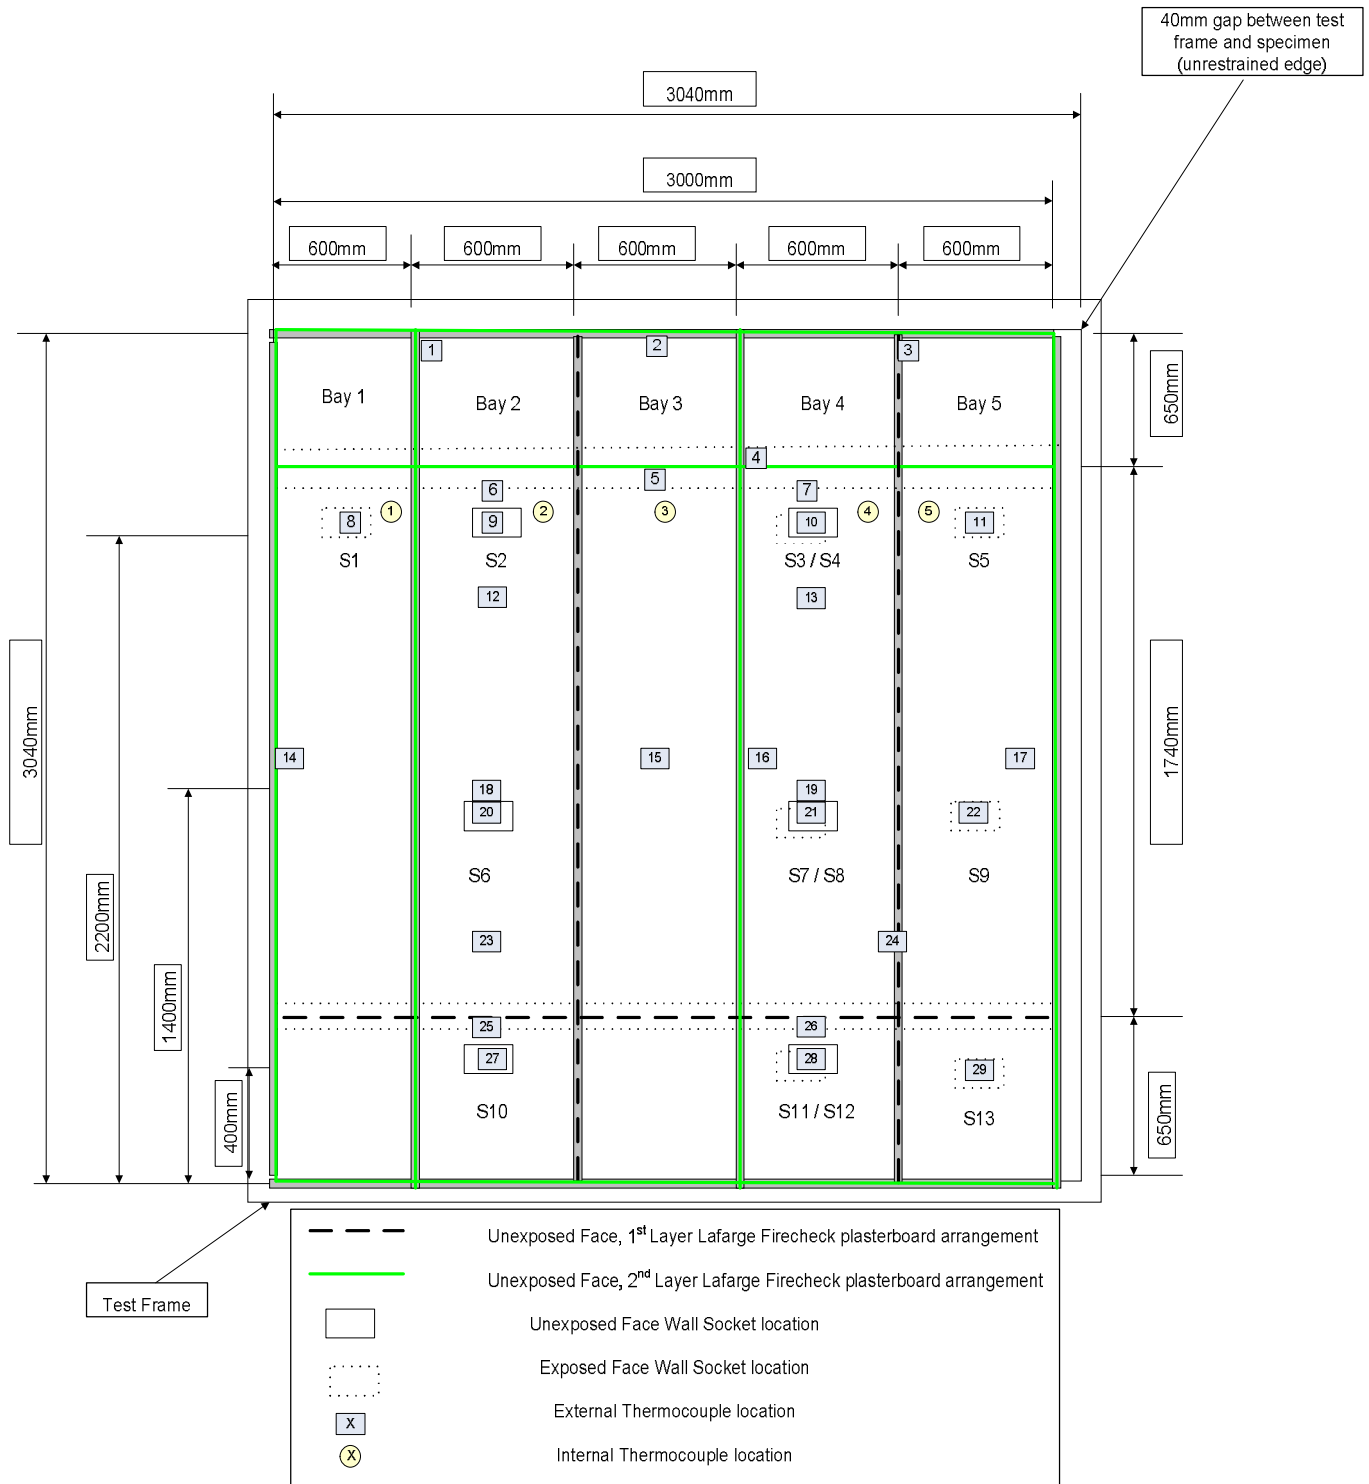
Figure 7: Showing the Internal and External Thermocouple locations on the Unexposed Face. (Drawing Not to Scale)

The location of these sockets is shown in Figure 1, 5, 6 and 7.

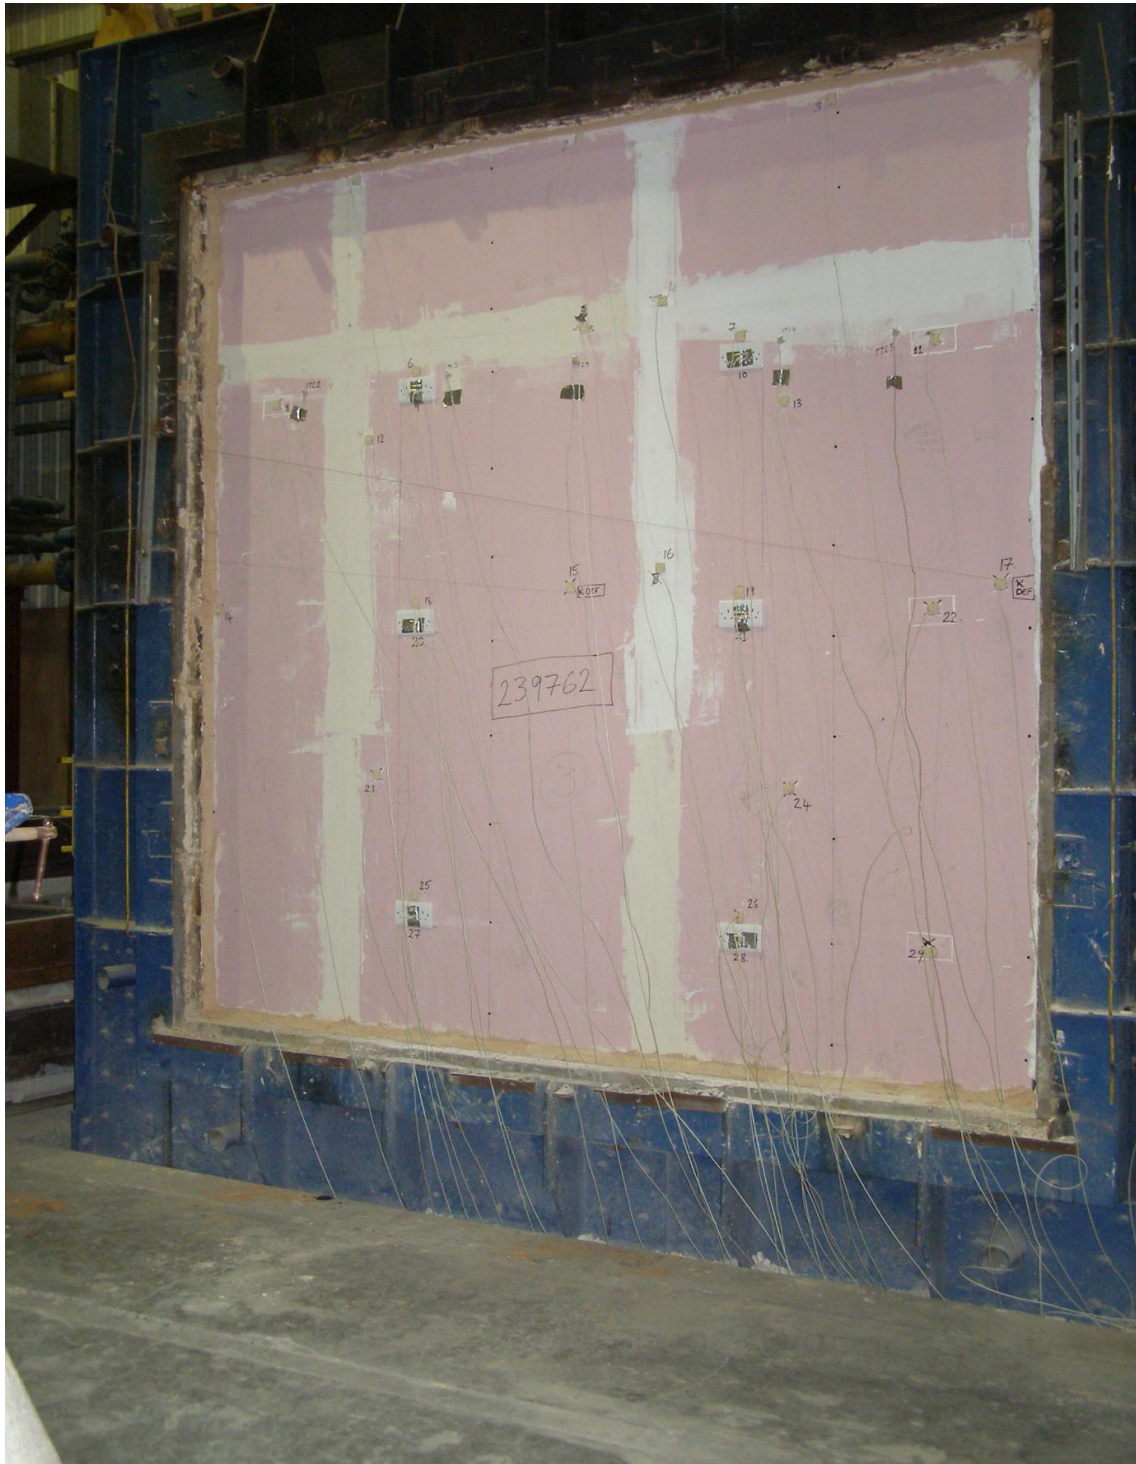
Photo 2: Unexposed face of the wall prior to start of test showing electrical sockets – *from left to right*- S2 and S3 (top row), S6 and S7 (middle row), S10 and S11 (bottom row)

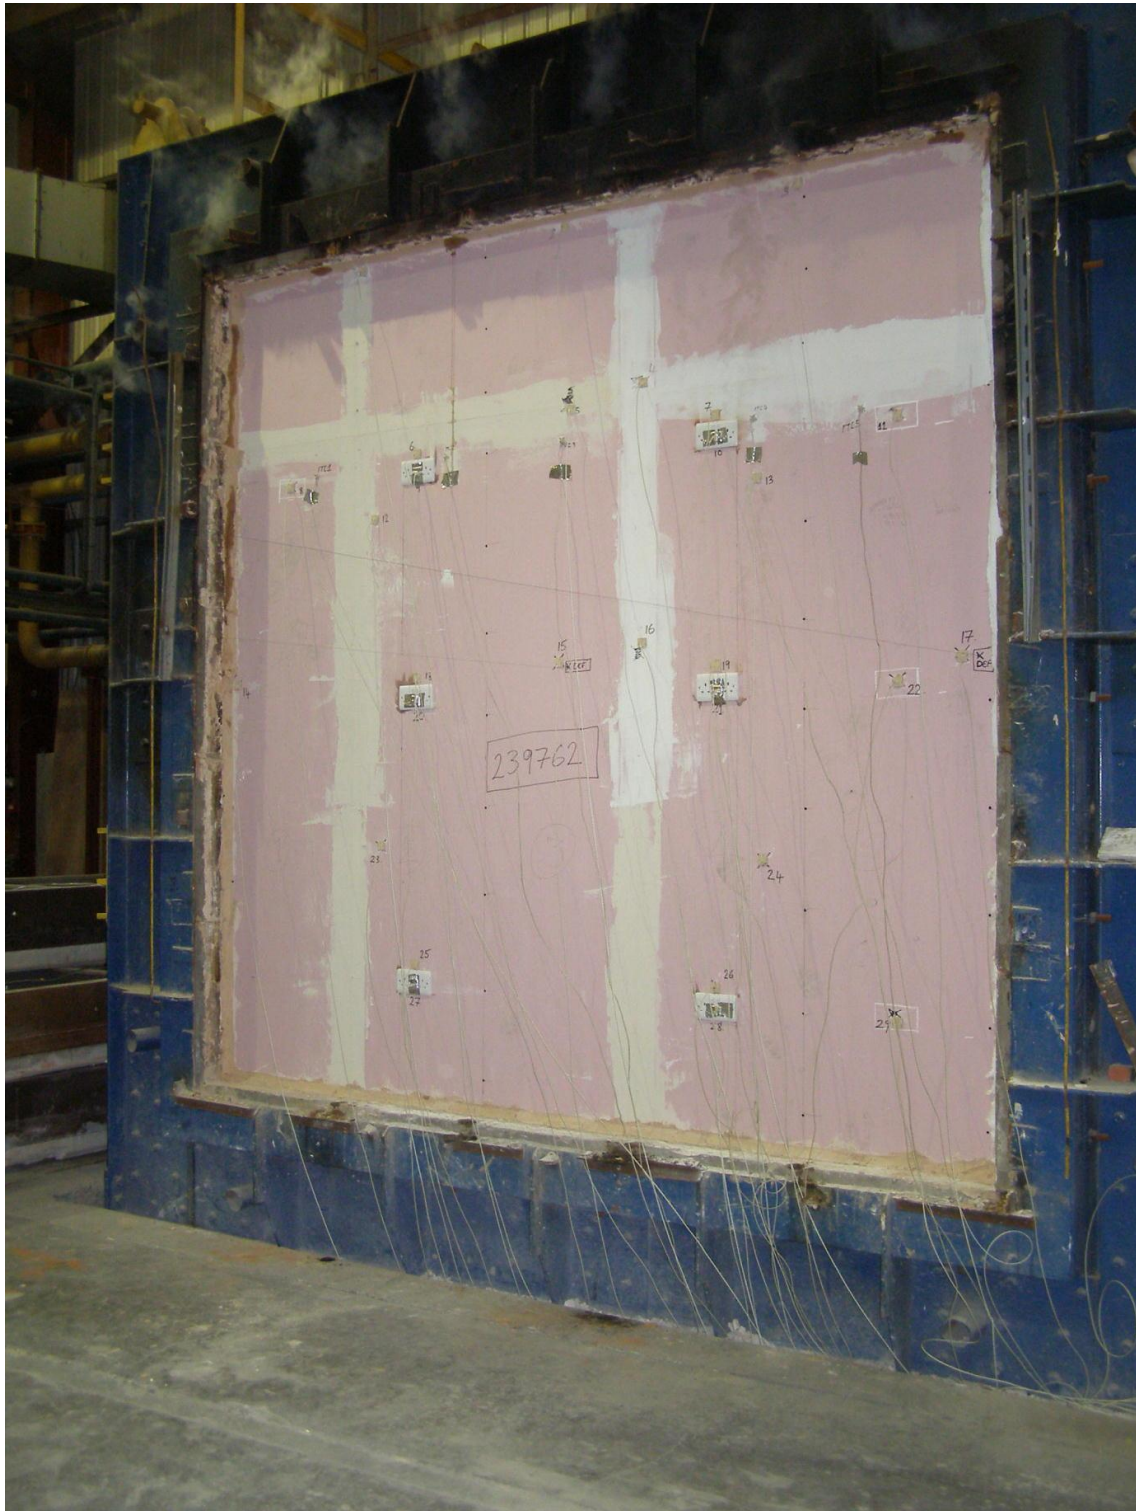
Photo 3: Unexposed face after 30 minutes from start of test

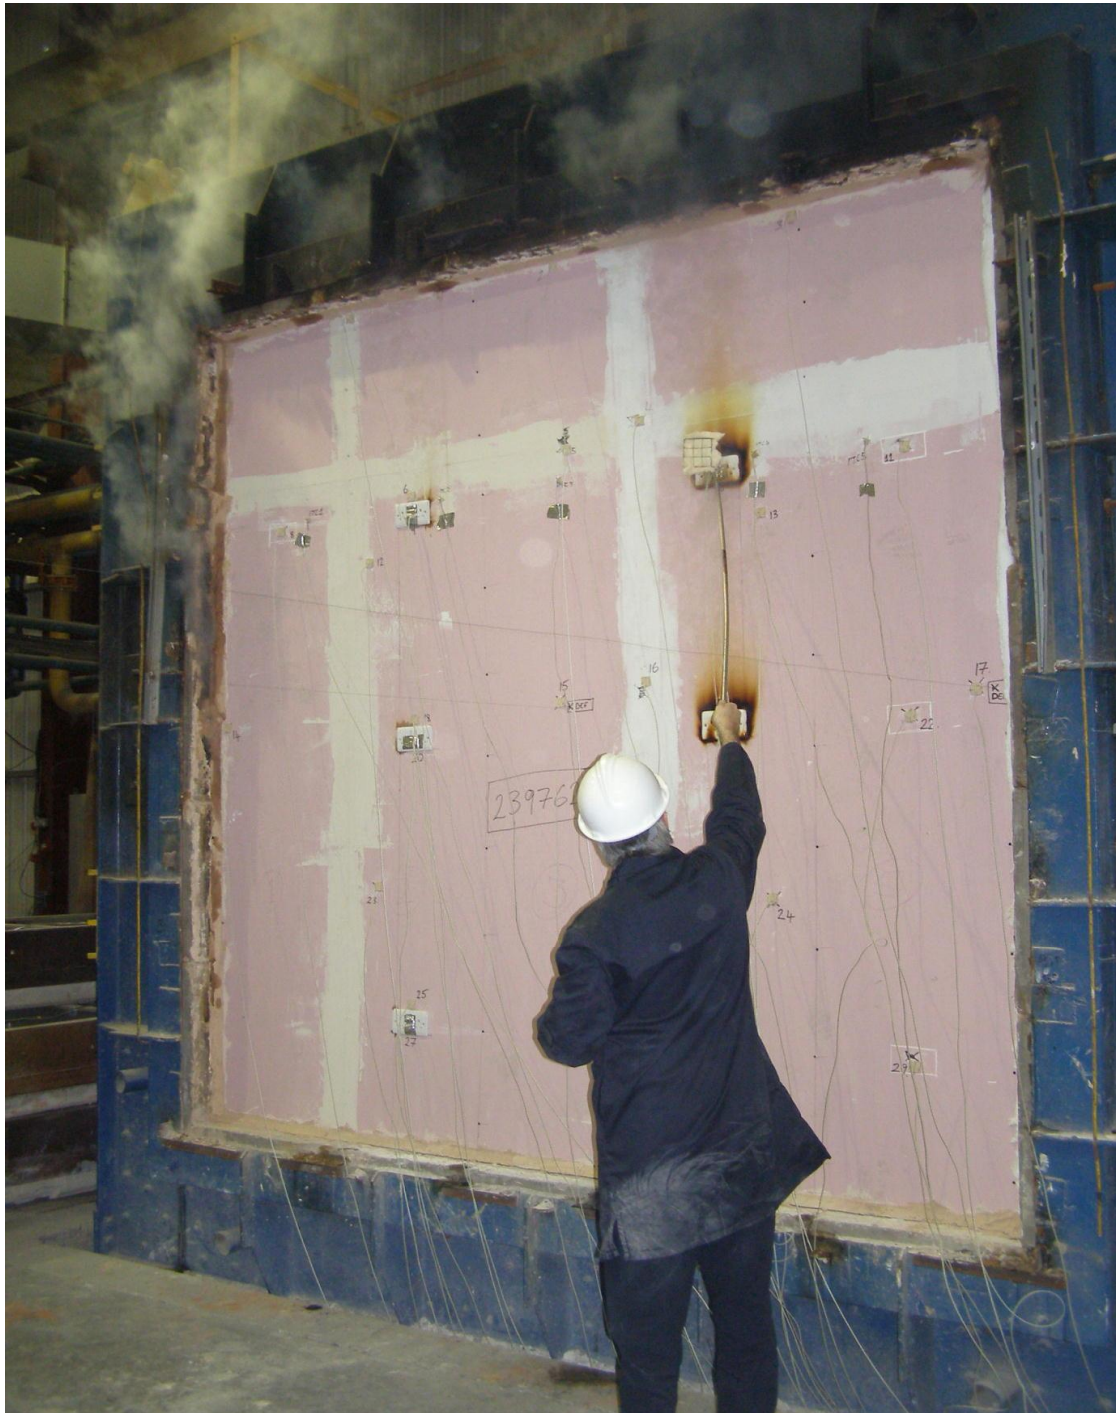
Photo 4: Unexposed face after 60 minutes from start of test

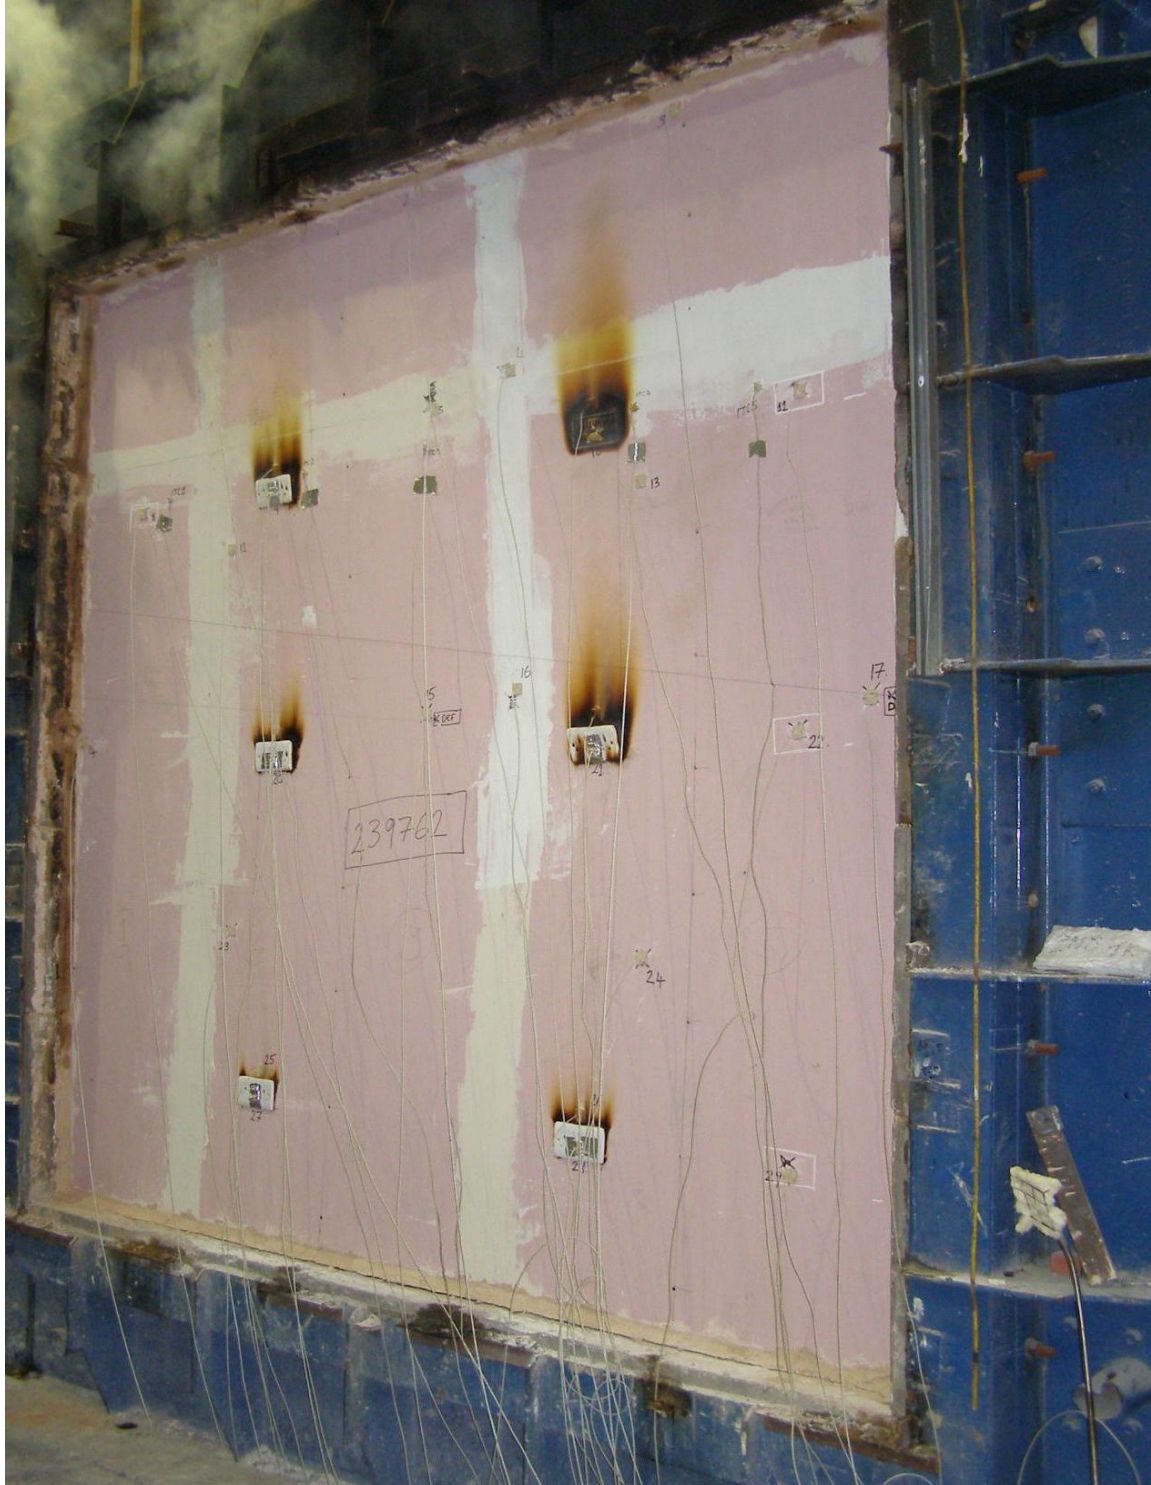
Photo 5: Unexposed face after 90 minutes from start of the test.

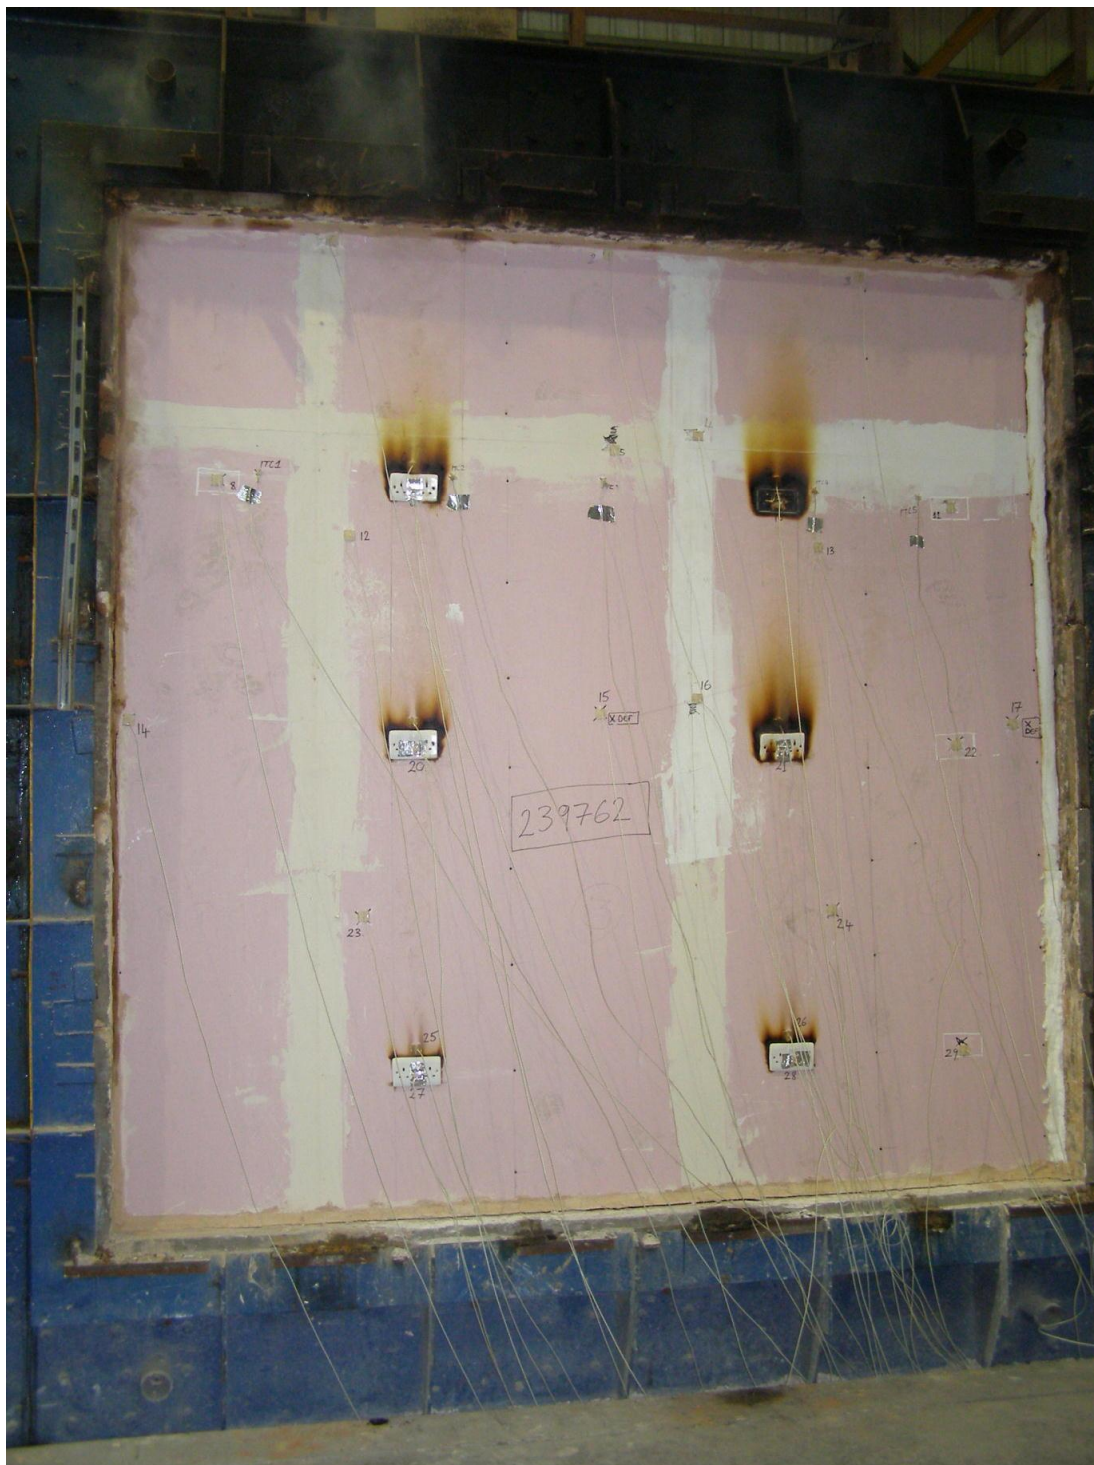
Photo 6: Unexposed face at termination of test, after 99 minutes duration
