Re: Indicative Fire Resistance Test Chilt/IF10090

This letter is to confirm the results of an indicative fire resistance test undertaken on 25th November 2010.

The specimen consisted of a section of floor fitted with two metal exhaust valves with associated ductwork.

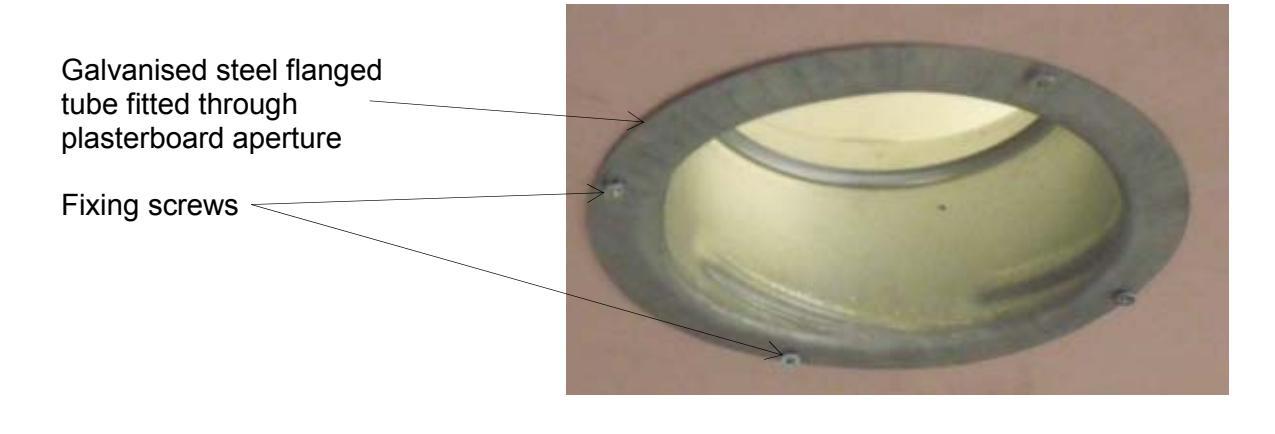
Air valve assembly Valve threaded stud Intumescent gasket fitted inside valve disc Foam seal

Air exhaust valve void B was fitted in the rear left void, positioned centrally in the void between the joists and noggins, and was referenced 'Tenmat Fire Rated ceiling valve 125mm' incorporating a 4mm thick x 92mm diameter intumescent gasket. The valve assembly had a flange outside diameter of 165mm and an inside diameter of 97mm and the approximate height of the valve assembly was 58mm. The valve disc measured 98mm diameter, with a 6mm diameter threaded stud welded to it.

The valve assembly was screw fitted into a galvanised steel flanged tube, fitted through a 168mm diameter cut out in the plasterboard; a 15mm wide x 10mm thick (uncompressed) foam sealing ring was fitted between the valve and tube flanges. The flanged steel tube was held in place in the ceiling aperture with 4No. 25mm long wood screws. A 4mm thick x 92mm diameter disc of Tenmat intumescent material (details held on file in confidence by CIFL) was fitted to the exposed side of the valve disc.

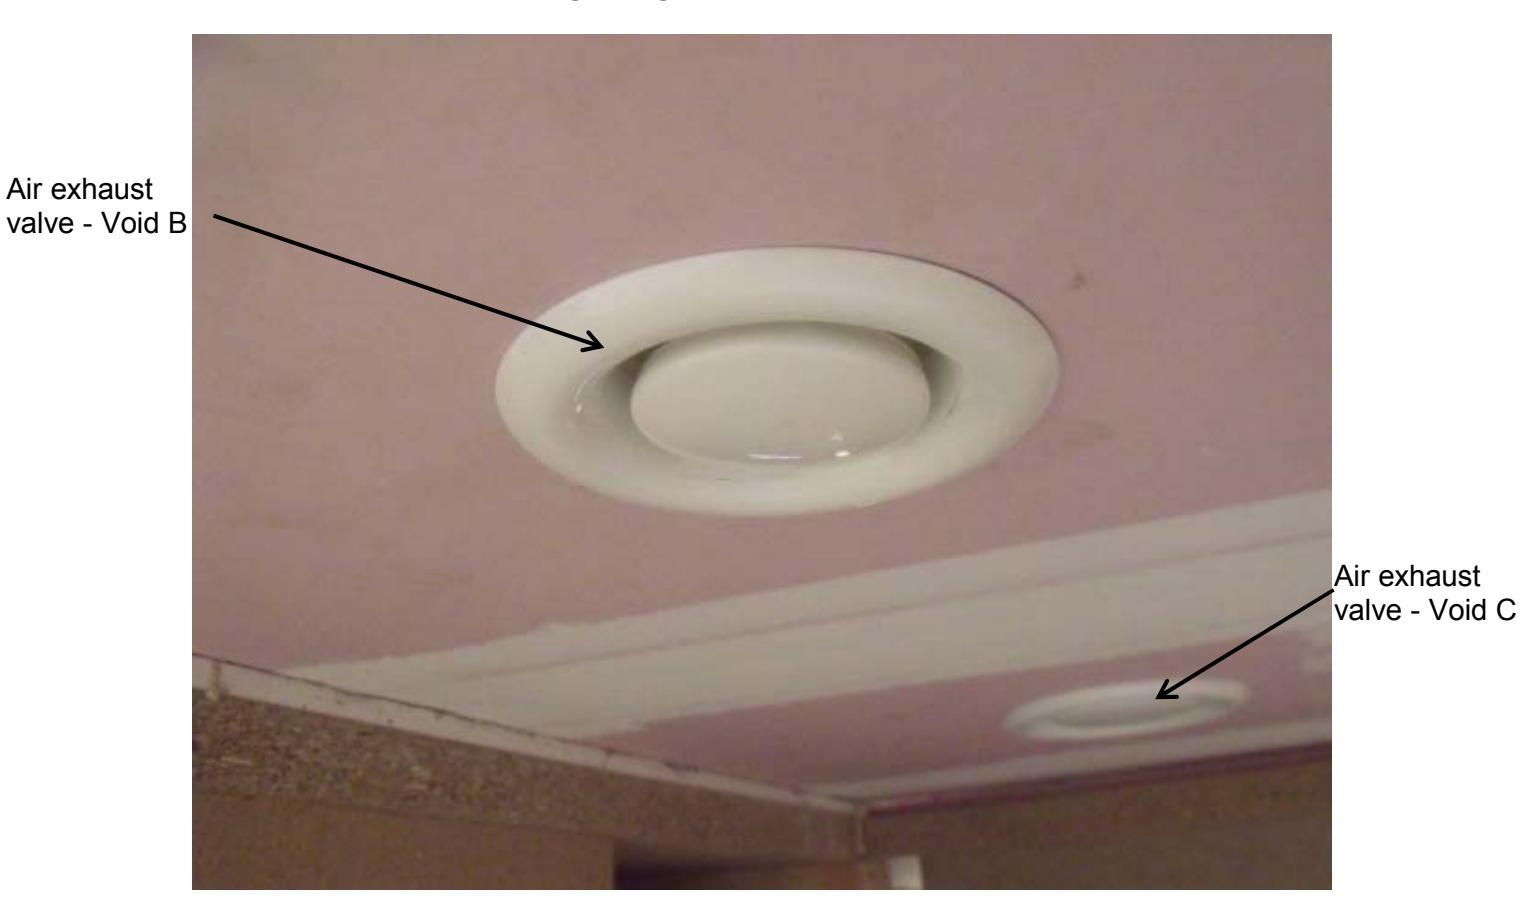
Exposed face – before the beginning of the test

The air valves were tested in the open position, with the exposed face of the valve disc flush with the face of the flange.

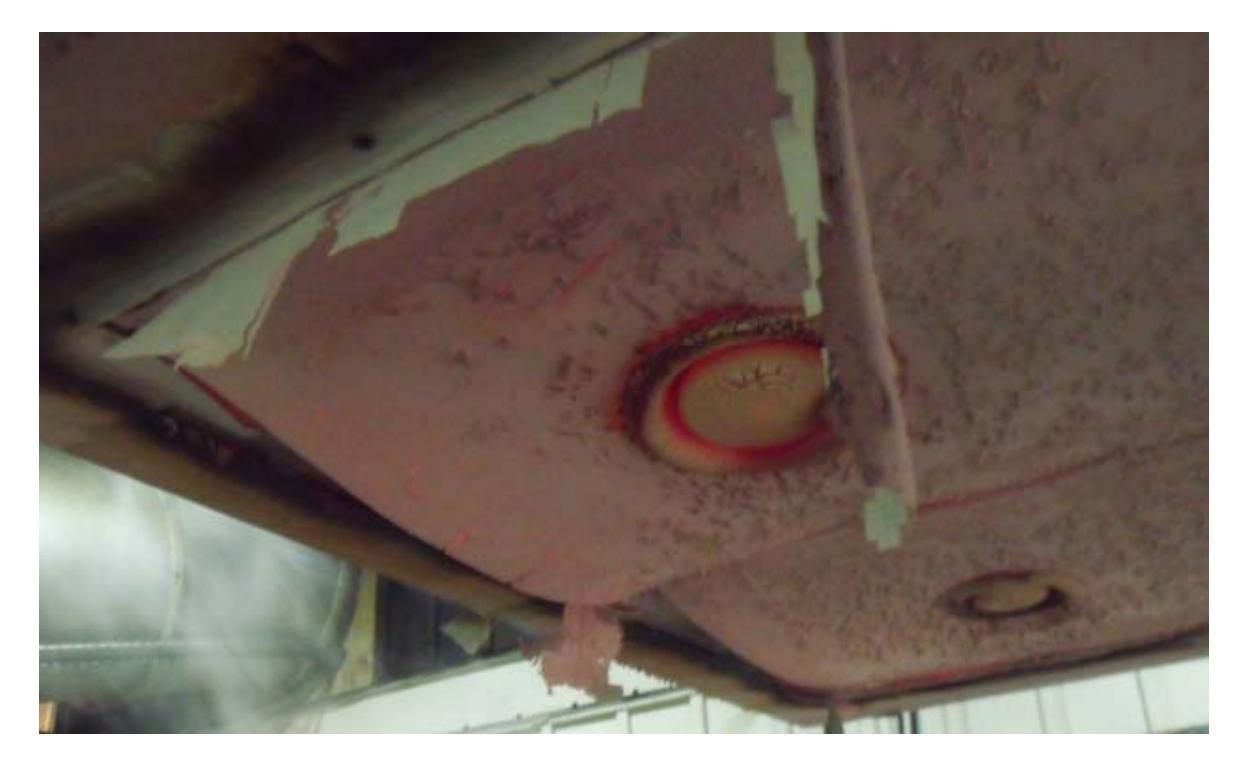
Exposed face – at the end of the test

There was a crack to both layers of the plaster board. There is no char to the side of the joists in any of the cavities. There is approximately 1-2mm charring on the bottom ends of the joists where they meet the plasterboard.

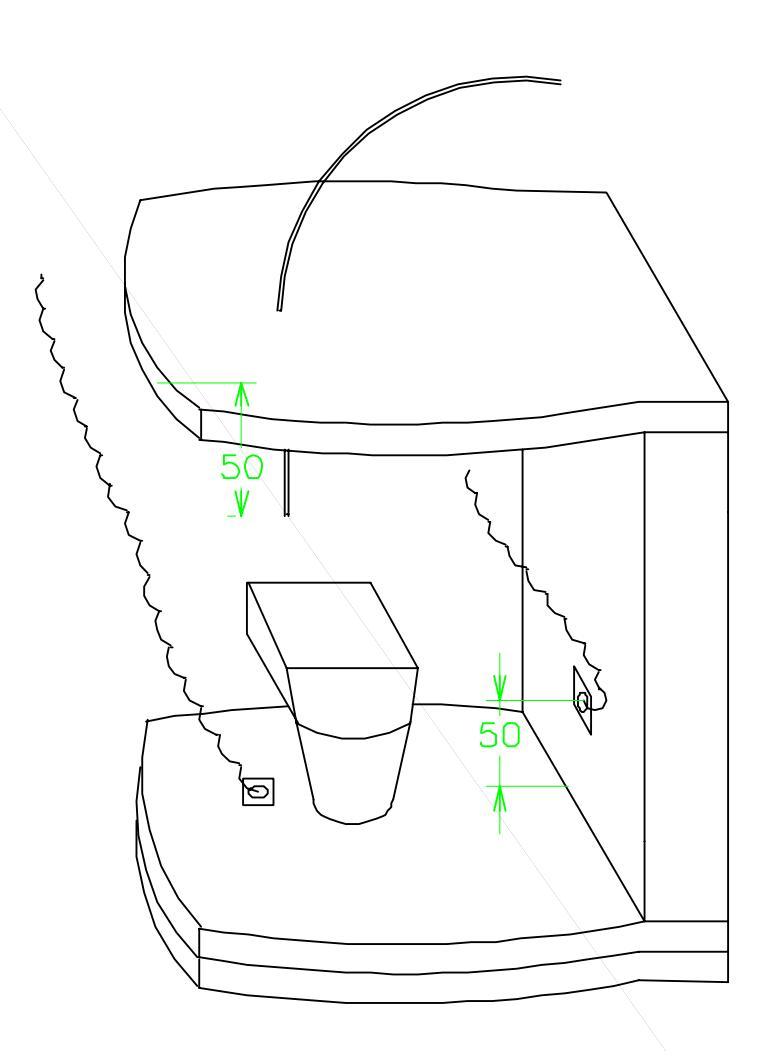
There were 3 internal thermocouples installed into three of the discrete areas of the specimen; one was fixed 50mm up from the plasterboard and mid width to the central joist, one was fixed to the unexposed face of the plasterboard and one was a 1.5mm \emptyset probe thermocouple fixed through the chipboard decking, reading 50mm from the underside of the decking. (see below)

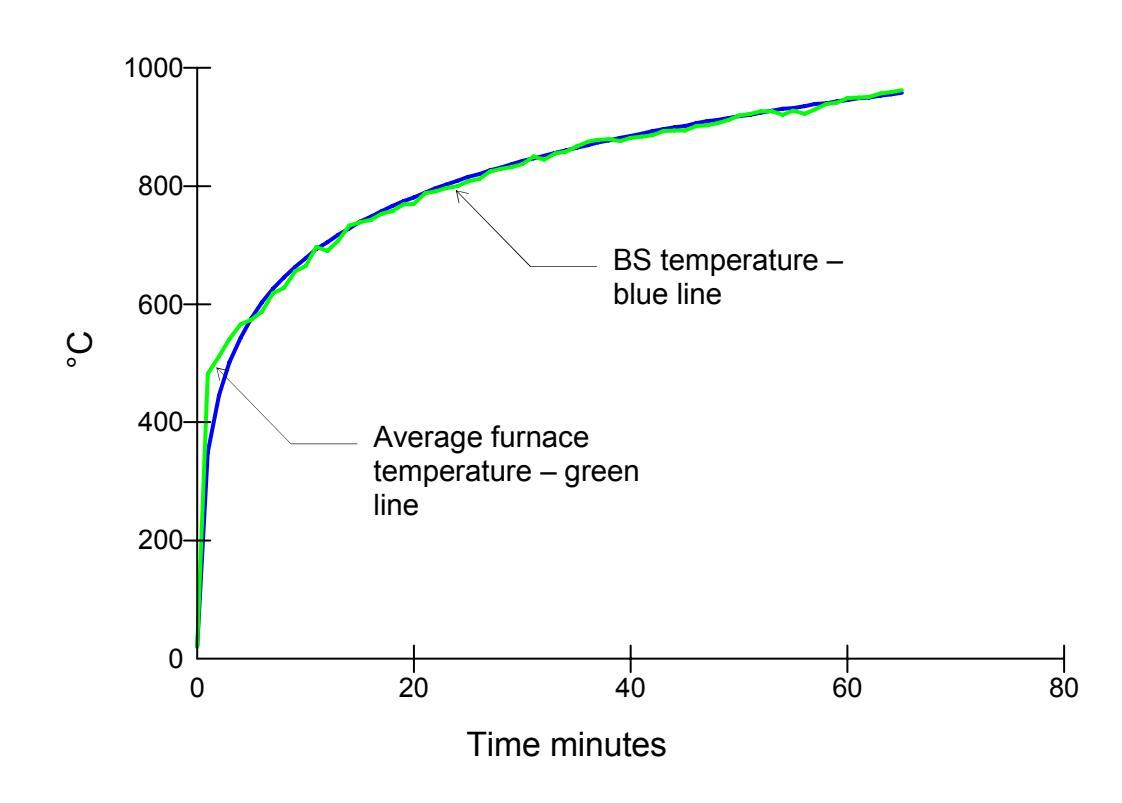
Furnace temperature curve

The furnace was controlled using the average of 4No furnace thermocouples to the temperature and pressure conditions outlined in BS 476: Part 20: 1987.

The pressure at the underside of the floor sample was maintained at 20 Pa.

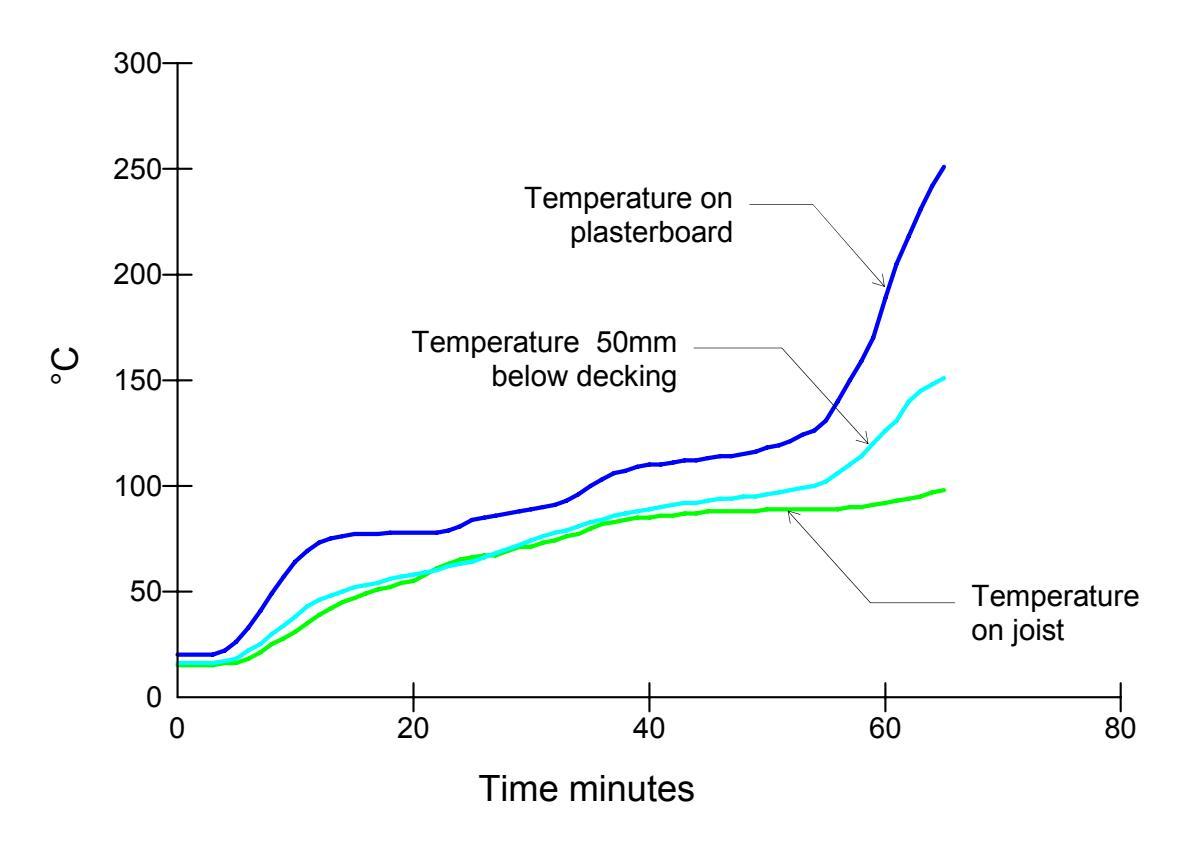
Void A (control reference)

Void temperature curves

30.00	Temperatures recorded 50mm below underside of decking:- Void A: 74°C, Void B: 105°C, Void C: 133°C Temperatures recorded 50mm above the plasterboard on central joist:- Void A: 71°C, Void B: 86°C, Void C: 84°C Temperatures recorded on plasterboard:- Void A: 89°C, Void B: 141°C Void C: 123°C

60.00	All fittings and plasterboard layers remain in position. There is a hairline crack in the first layer of the plaster board. There is a gap between the central join opened to approximately 15mm. Temperatures recorded 50mm below underside of decking:- Void A: 126°C, Void B: 175°C, Void C: 203°C Temperatures recorded 50mm above the plasterboard on central joist:- Void A: 92°C, Void B: 133°C, Void C: 142°C Temperatures recorded on plasterboard:- Void A: 189°C, Void B: 217°C, Void C: 203°C
